# Inspection Report

**Property Address:**  
123 Any Street  
Plymouth MN 55447

### Eagle Home Inspection

<b>Date:</b> 4/17/2014	<b>Time:</b>	<b>Report ID:</b> 00002014987
<b>Property:</b> 123 Any Street Plymouth MN 55447	<b>Customer:</b> Sample Sample	<b>Real Estate Professional:</b>

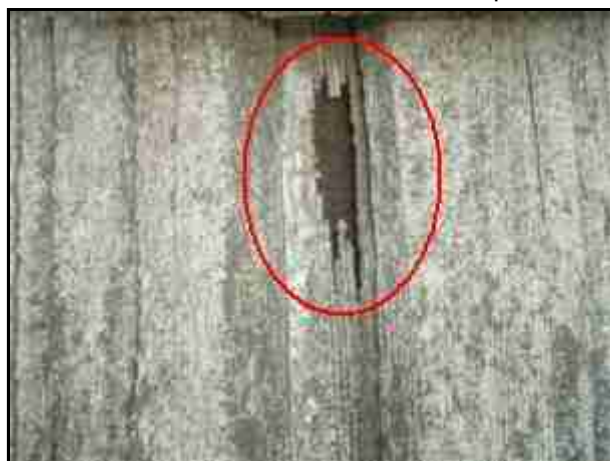
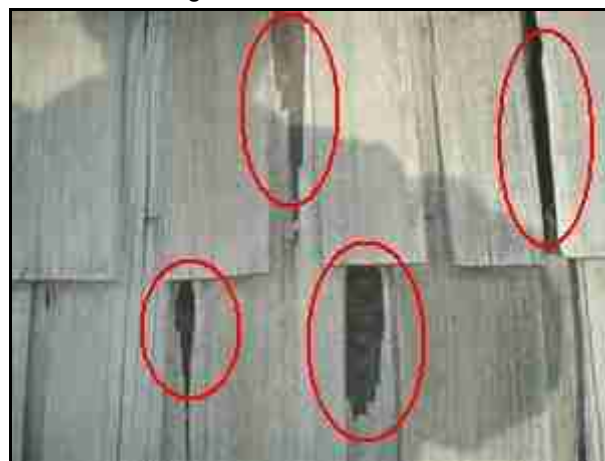
**1.0 CONDITION: Cedar Shake Deterioration**

**EXPLANATION:** Cedar shake shingles will eventually deteriorate at this location, the shake is thinner at this point and may also trap roof debris which will speed up the deterioration. This exposes the underlayment (which is the actual component that keeps your roof from leaking), to harmful UV light eventually causing it to deteriorate which will then cause your roof to leak. Typically these areas can be covered up by installing wood shims which will prolong the life of the roof.

**IMPACT/CONSEQUENCES:** Damage To Underlayment, Eventual Roof Leak If Not Addressed.

**RECOMMENDED ACTION:** Consult with a qualified cedar shake roofing contractor for best course of action.

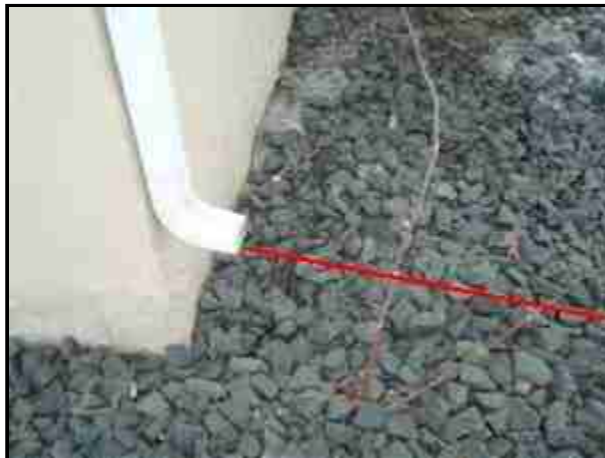
1.2 Picture 1

**1.2 CONDITION: Missing Downspout Extension**

**IMPACT/CONSEQUENCES:** Gutter systems that do not operate as intended will add to the potential of basement water intrusion and possible foundation cracking and movement.

**RECOMMENDED ACTION:** Install extensions

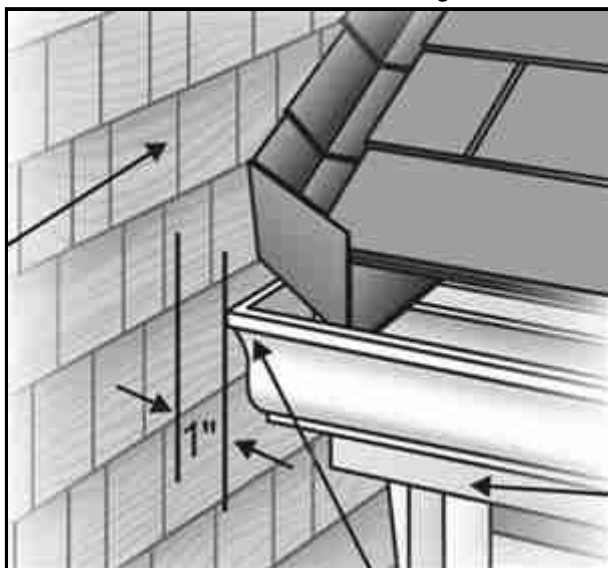
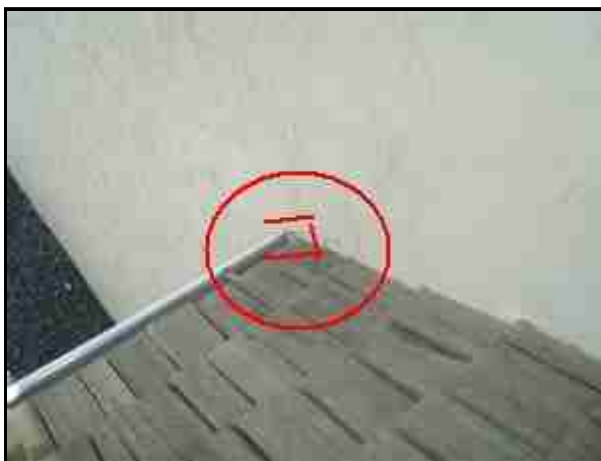
#### 1.4 CONDITION: **Kick Out Flashing Missing**

**IMPACT/CONSEQUENCES:** Increased potential of water entering wall cavity at this location causing interior damage to wall cavity, (not visible without removing siding)

**RECOMMENDED ACTION:** Consult with siding contractor for further inspection to this area and best course of action and installation of kick out flashing.

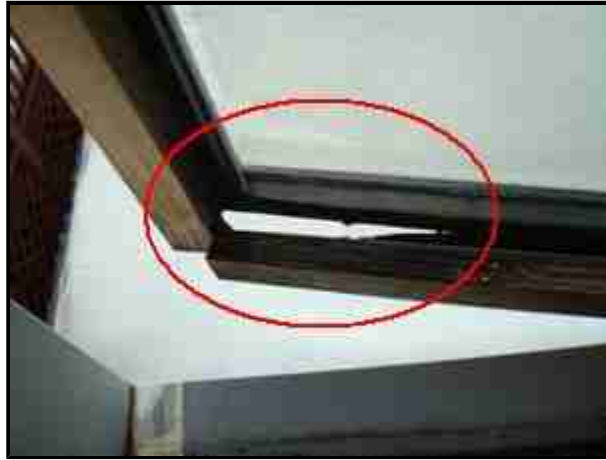
2.3 Picture 1

#### 2.3 CONDITION: Rotted Window Trim

**EXPLANATION:** Exposed unpainted wood will eventually rot, paint is not only cosmetic but also protects and preserves wood.

**IMPACT/CONSEQUENCES:** Moisture intrusion in wall cavity under window, Window structure compromised, rotted wood provides a home for insects.

**RECOMMENDED ACTION:** Consult with a window contractor for repairs or replacement.

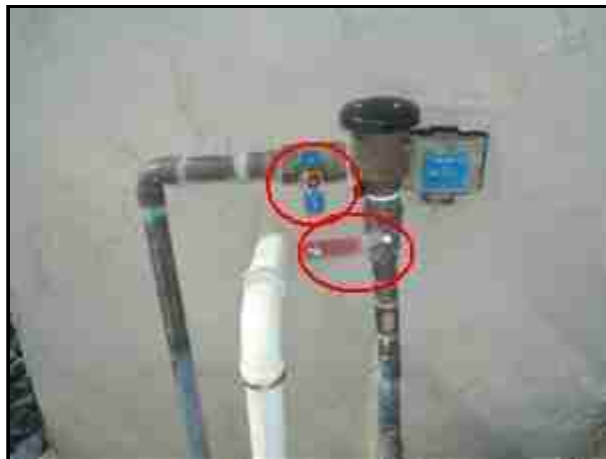
3.5 Picture 1

**3.5 CONDITION: Lawn Sprinkler Not Inspected**

**IMPACT/CONSEQUENCES:** Unknown defects

**RECOMMENDED ACTION:** Consult with a qualified underground sprinkler service for annual winterizing and spring time de winterizing, at that time have them teach you how to operate the system throughout the summer months.

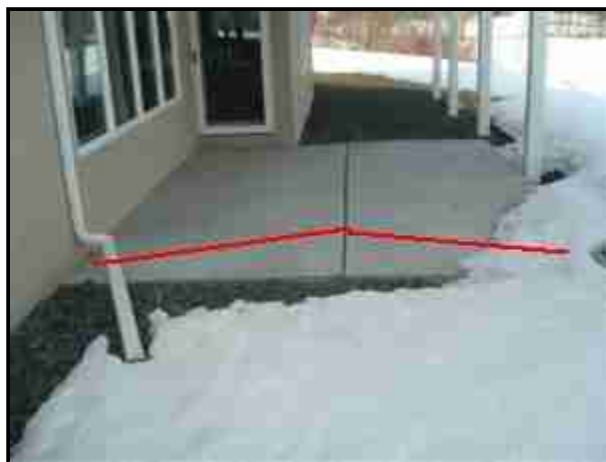
3.6 Picture 1

### 3.6 CONDITION: **Patio Slopes Towards House**

**EXPLANATION:** Ground surface should slope away from the house at a minimum of 6 inches slope per 10 feet away from the house to properly channel water away from the foundation of the house.

**IMPACT/CONSEQUENCES:** Increased potential of foundation movement and basement moisture intrusion.

**RECOMMENDED ACTION:** Consult with a qualified concrete contractor to determine best course of action for improvements.

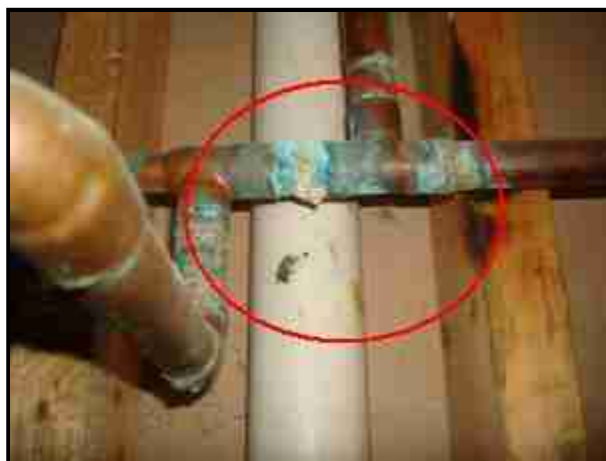
6.0 Picture 1

**Comments:**
**6.0 CONDITION: Corrosion On Supply Pipe Components**
**LOCATION:** Supply Pipes In Utility Room

**EXPLANATION:** Corrosion on copper supply pipe connections is a sign of a VERY slow leak that may leak intermittently. Its possible that this may never drip but in most cases the leak will get worse.

**IMPACT/CONSEQUENCES:** Leak At Fitting, Water Damage To Home

**RECOMMENDED ACTION:** Consult with a qualified plumber to re solder these connections.

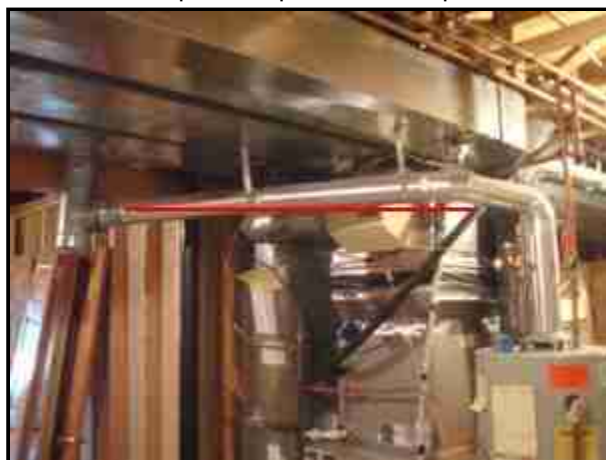
6.2 Picture 1

**6.2 CONDITION: Negative Slope On Water Heater Vent Pipe****LOCATION:** Water Heater**EXPLANATION:** Generally the vent pipe on a water heater should slope up away from the water heater at a minimum of 1/4" per foot of pipe unless otherwise specified in the manufacturers installation guide.**IMPACT/CONSEQUENCES:** Water Heater May Vent Into House, Carbon Monoxide Hazard.**RECOMMENDED ACTION:** Consult with a qualified plumber for repairs.

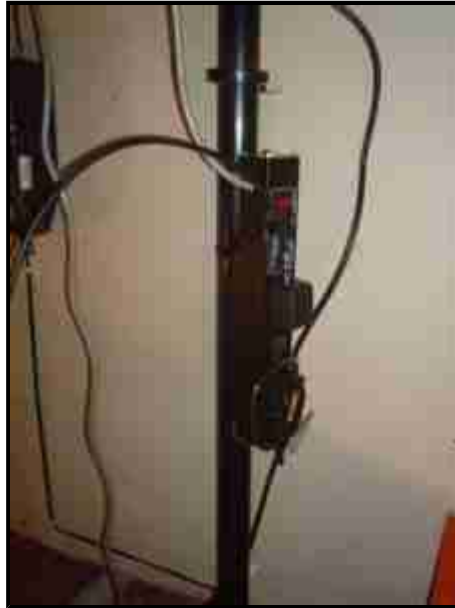
7.3 Picture 1

**Comments:**
**7.3 (1) CONDITION: Extension Cord Used As Permanent Wiring**

**IMPACT/CONSEQUENCES:** Fire Hazard

**RECOMMENDED ACTION:** Consult with a qualified electrician for installation of an outlet receptacle in this location to replace the extension cord.

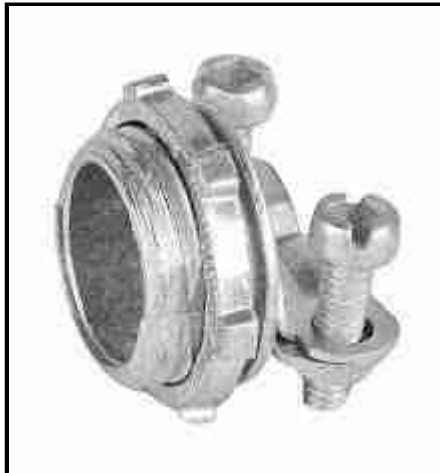
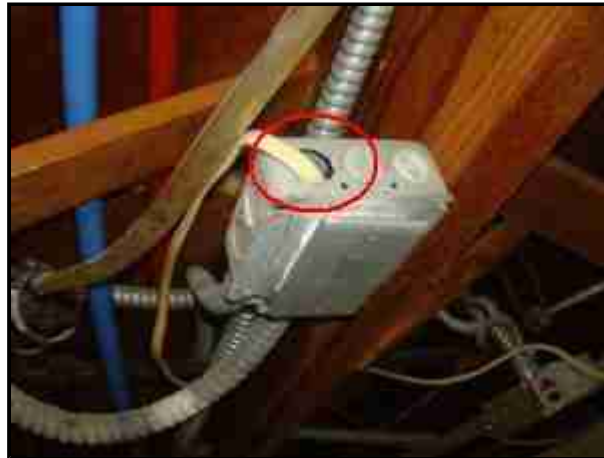
**(2) CONDITION: Missing Junction Box Cable Clamp****LOCATION:** Utility Room**EXPLANATION:** The cable clamp secures the romex wire to the junction box and protects it from rubbing on the sharp edge of the junction box, this is a sign of amateur workmanship.**IMPACT/CONSEQUENCES:** Short Circuit, Electrical Shock Hazard.**RECOMMENDED ACTION:** Consult with a qualified electrician for repairs.

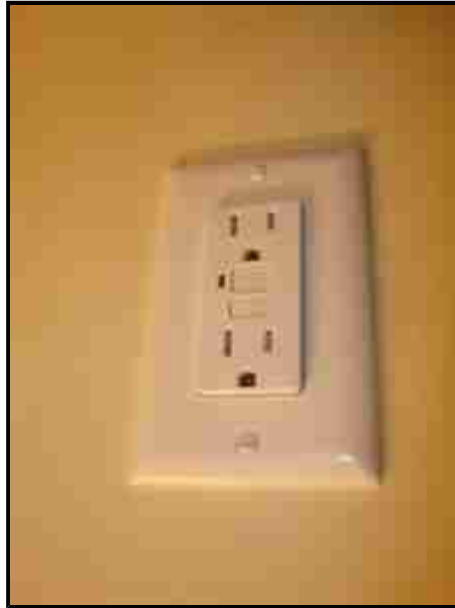
7.6 Picture 1

**7.6 CONDITION: GFCI Outlet Receptacle Did Not Trip When Tested****LOCATION:** Basement Bathroom**EXPLANATION:** GFCI (ground fault circuit interrupter) are very sensitive to any imbalance of current between the hot and neutral wire, if an imbalance is sensed it will trip, cutting the power to the outlet, this is intended to protect you from an electrical shock.**IMPACT/CONSEQUENCES:** Electrical Shock Hazard**RECOMMENDED ACTION** Consult with a qualified electrician for replacement.

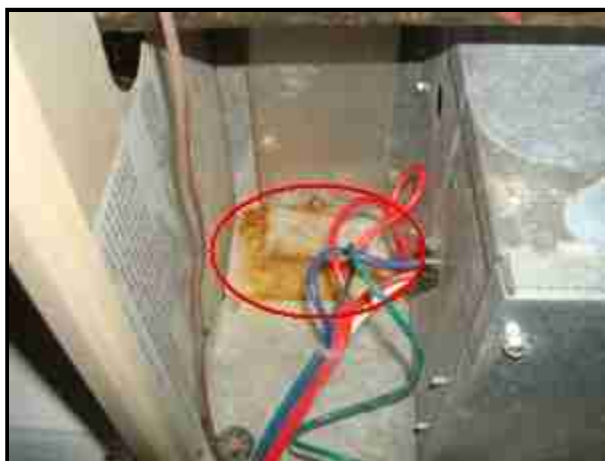
8.1 Picture 1

**8.1 (1) CONDITION: Leaking Evaporator Pan/Rust On Furnace**
**LOCATION:** Furnace

**EXPLANATION:** The evaporator pan catches the condensate water from the air conditioners evaporator coil, these can plug up with debris causing them to overflow onto the furnace.

**IMPACT/CONSEQUENCES:** Water Damage To Various Components Of The Furnace.

**RECOMMENDED ACTION:** Consult with a HVAC contractor for service/repairs.

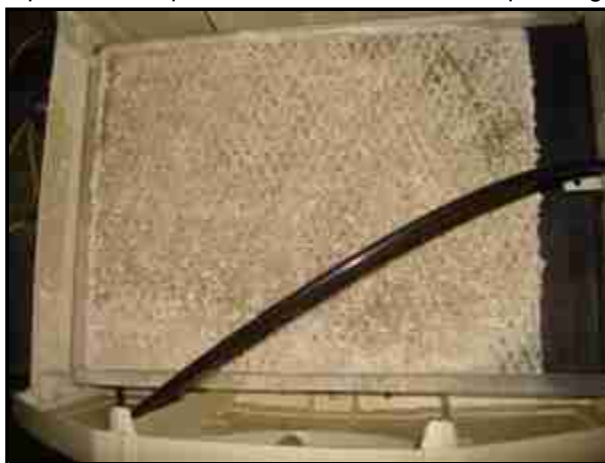
8.9 Picture 1

**8.9 CONDITION: Plugged/Dirty Water Tray**

**LOCATION:** Humidifier On Furnace

**EXPLANATION:** A built in humidifier allows water to run over it and air to blow through it, the air evaporates water leaving behind mineral/calcium build up. These need to be periodically replaced depending on frequency of use and water chemistry. Water trays can be purchased at home improvement and hardware stores.

**IMPACT/CONSEQUENCES:** Overflow Causing Damage To Furnace Components

**RECOMMENDED ACTION:** Replace water plate now and as needed depending on use.

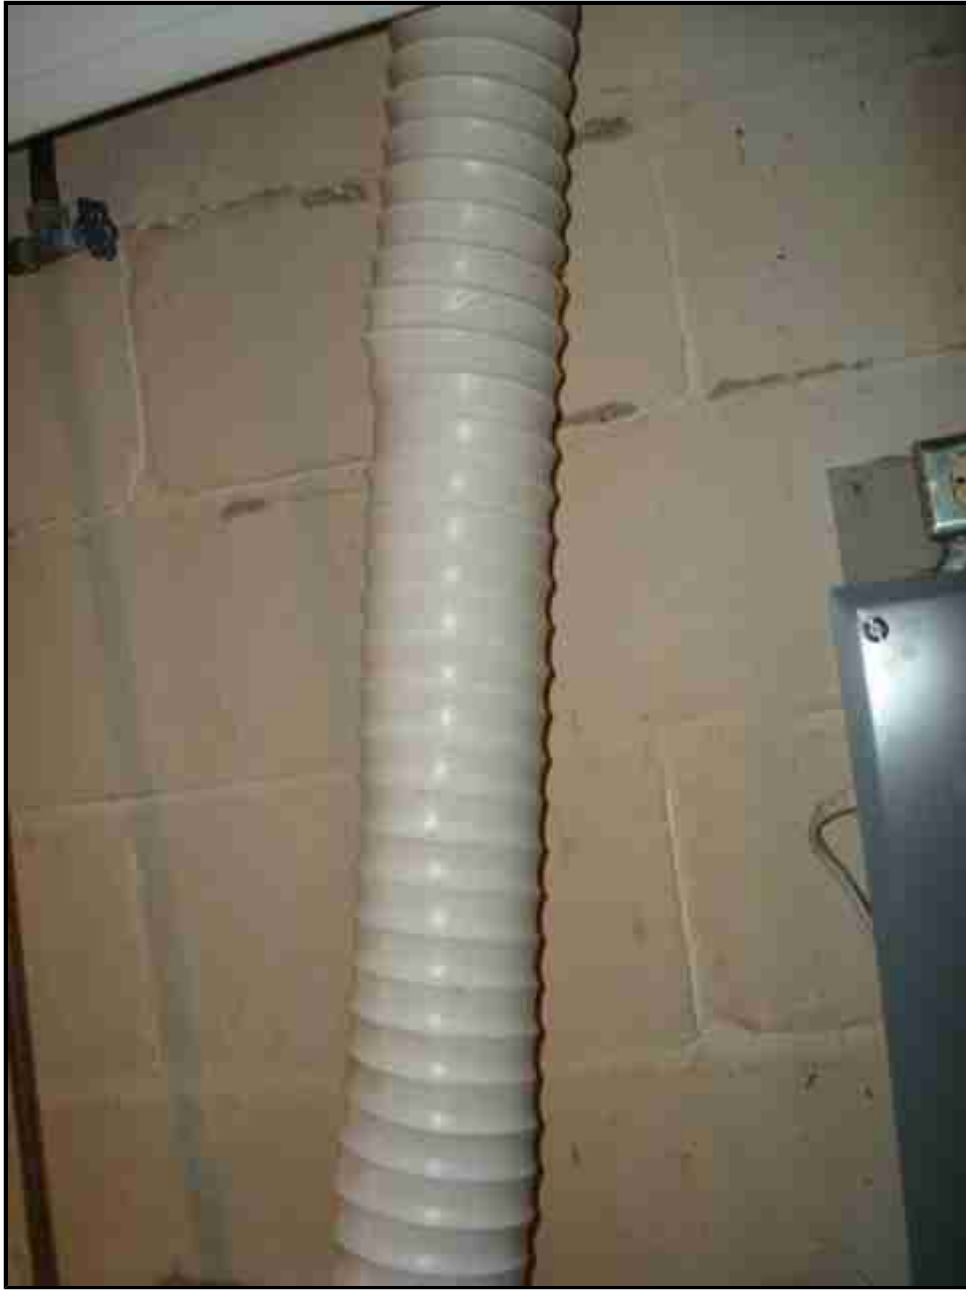
10.10 Picture 1

**Comments:**
**10.10 CONDITION: Plastic Clothes Dryer Vent Pipe**
**LOCATION:** Clothes Dryer

**IMPACT/CONSEQUENCES:** Fire Hazard

**RECOMMENDED ACTION:** Consult with a qualified contractor for replacement.

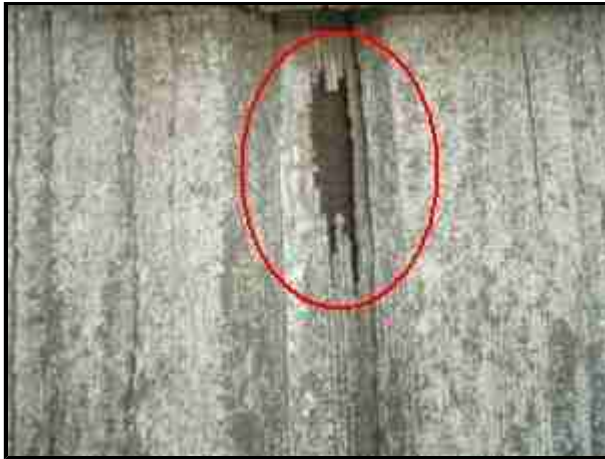
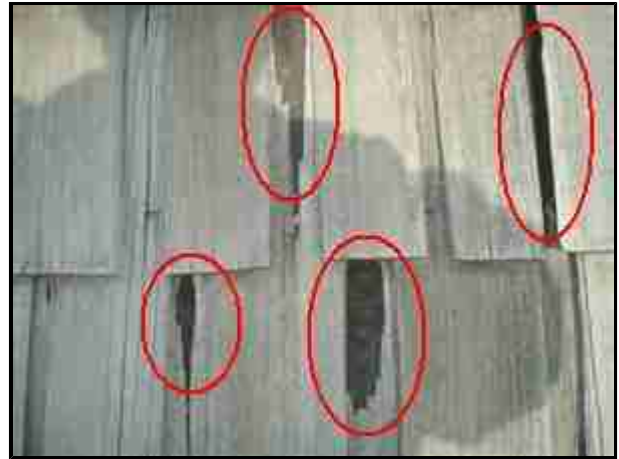
**CONDITION:** Cedar Shake Deterioration

**IMPACT/CONSEQUENCES:** Damage To Underlayment, Eventual Roof Leak If Not Addressed.

**RECOMMENDED ACTION:** Consult with a qualified cedar shake roofing contractor for best course of action.

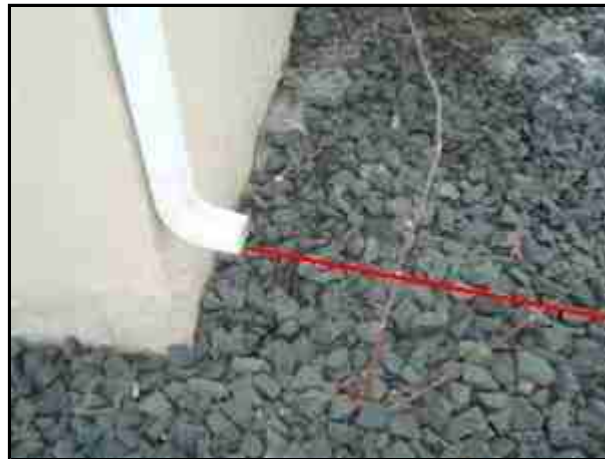
1.2 Picture 1

**CONDITION:** **Missing Downspout Extension**

**IMPACT/CONSEQUENCES:** Gutter systems that do not operate as intended will add to the potential of basement water intrusion and possible foundation cracking and movement.

**RECOMMENDED ACTION:** Install extensions

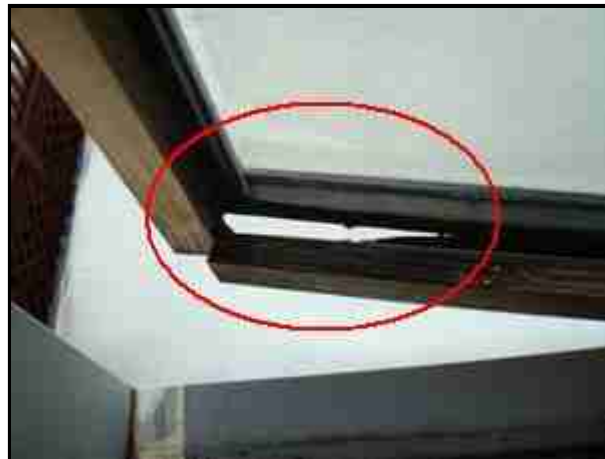
2.3 Picture 1

**IMPACT/CONSEQUENCES:** Moisture intrusion in wall cavity under window, Windowstructure compromised, rotted wood provides a home for insects.

**RECOMMENDED ACTION:** Consult with a window contractor for repairs or replacement.

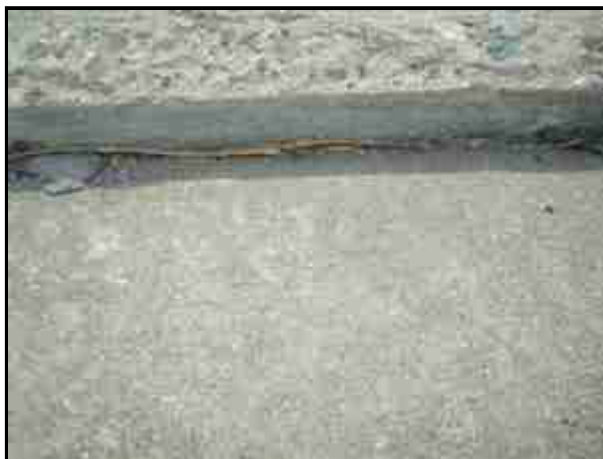
3.3 Picture 1

**IMPACT/CONSEQUENCES:** Trip Hazard

**RECOMMENDED ACTION:** In summer when the ground is not frozen re check this area, if not leveled out then consult with a qualified concrete mud/sand jack contractor for leveling and best course of action to prevent further movement.

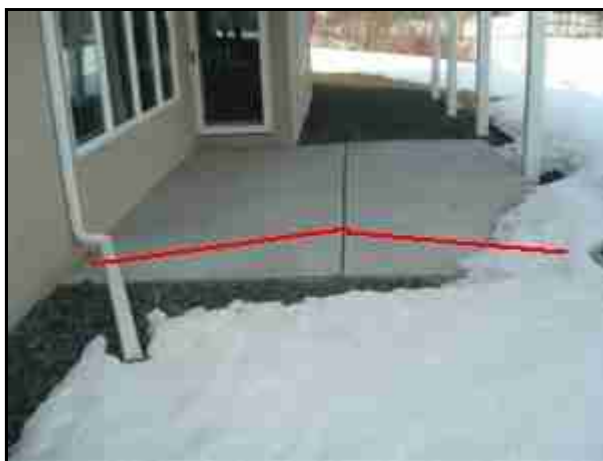
3.6 Picture 1

**IMPACT/CONSEQUENCES:** Increased potential of foundation movement and basement moisture intrusion.

**RECOMMENDED ACTION:** Consult with a qualified concrete contractor to determine best course of action for improvements.

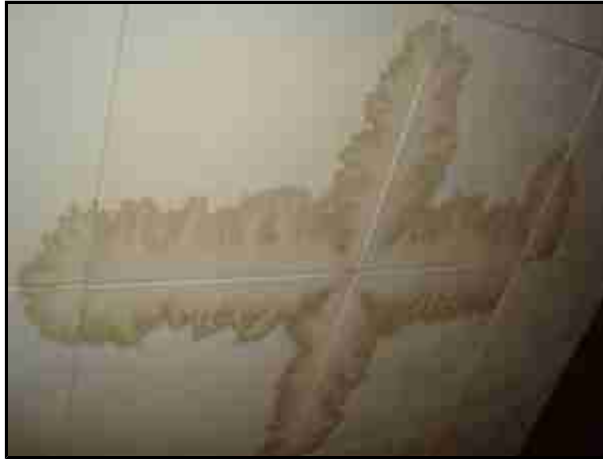
4.0 Picture 1

**IMPACT/CONSEQUENCES:** Possible Hidden Leak

**RECOMMENDED ACTION:** Consult with sellers for further explanation and documentation that a repair has been made. If not possible then monitor for wetness and have repairs made if needed.

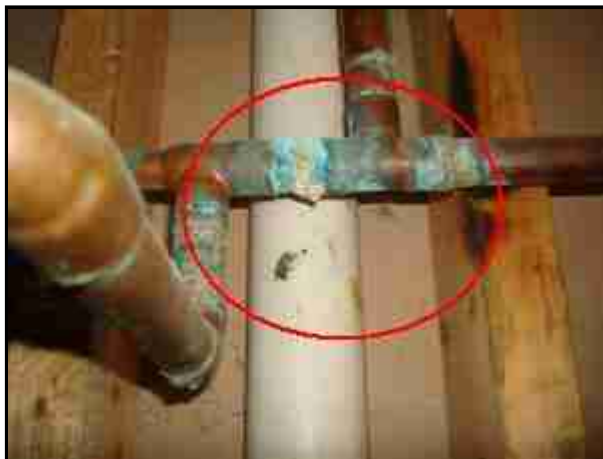
6.0 Picture 1

**IMPACT/CONSEQUENCES:** Leak At Fitting, Water Damage To Home

**RECOMMENDED ACTION:** Consult with a qualified plumber to re solder these connections.

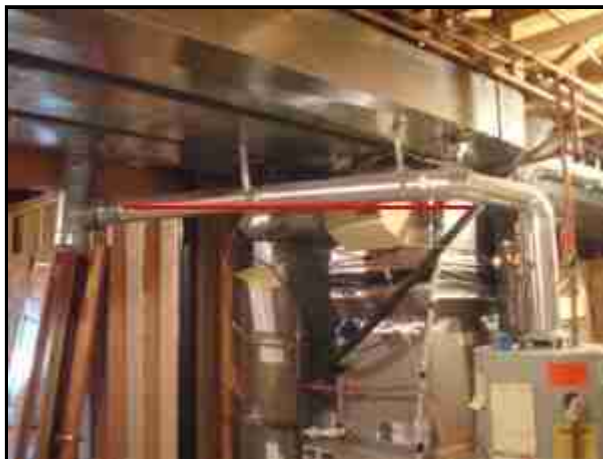
6.2 Picture 1

**IMPACT/CONSEQUENCES:** Water Heater May Vent Into House, Carbon Monoxide Hazard.

**RECOMMENDED ACTION:** Consult with a qualified plumber for repairs.

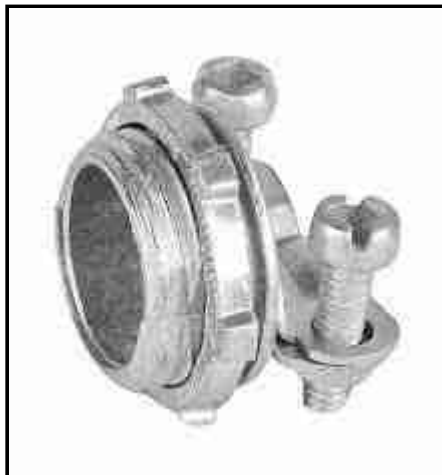
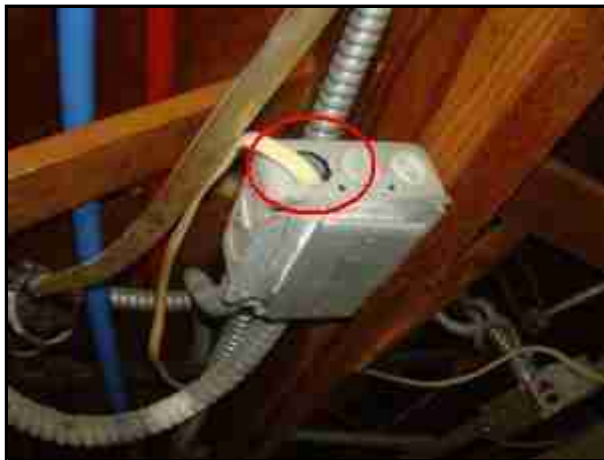
(2) **CONDITION: Missing Junction Box Cable Clamp**

**IMPACT/CONSEQUENCES:** Short Circuit, Electrical Shock Hazard.

**RECOMMENDED ACTION:** Consult with a qualified electrician for repairs.

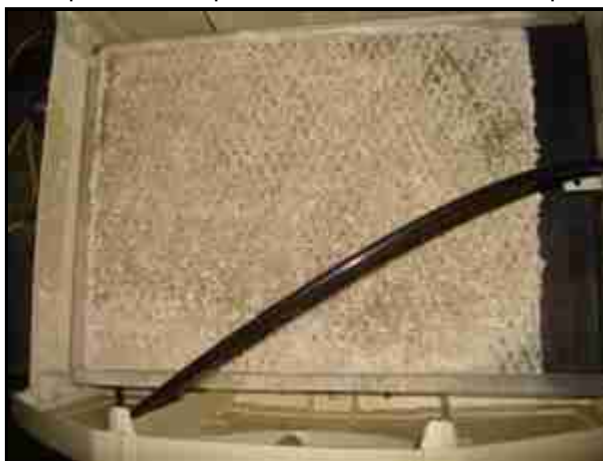
8.9 Picture 1

**IMPACT/CONSEQUENCES:** Overflow Causing Damage To Furnace Components

**RECOMMENDED ACTION:** Replace water plate now and as needed depending on use.

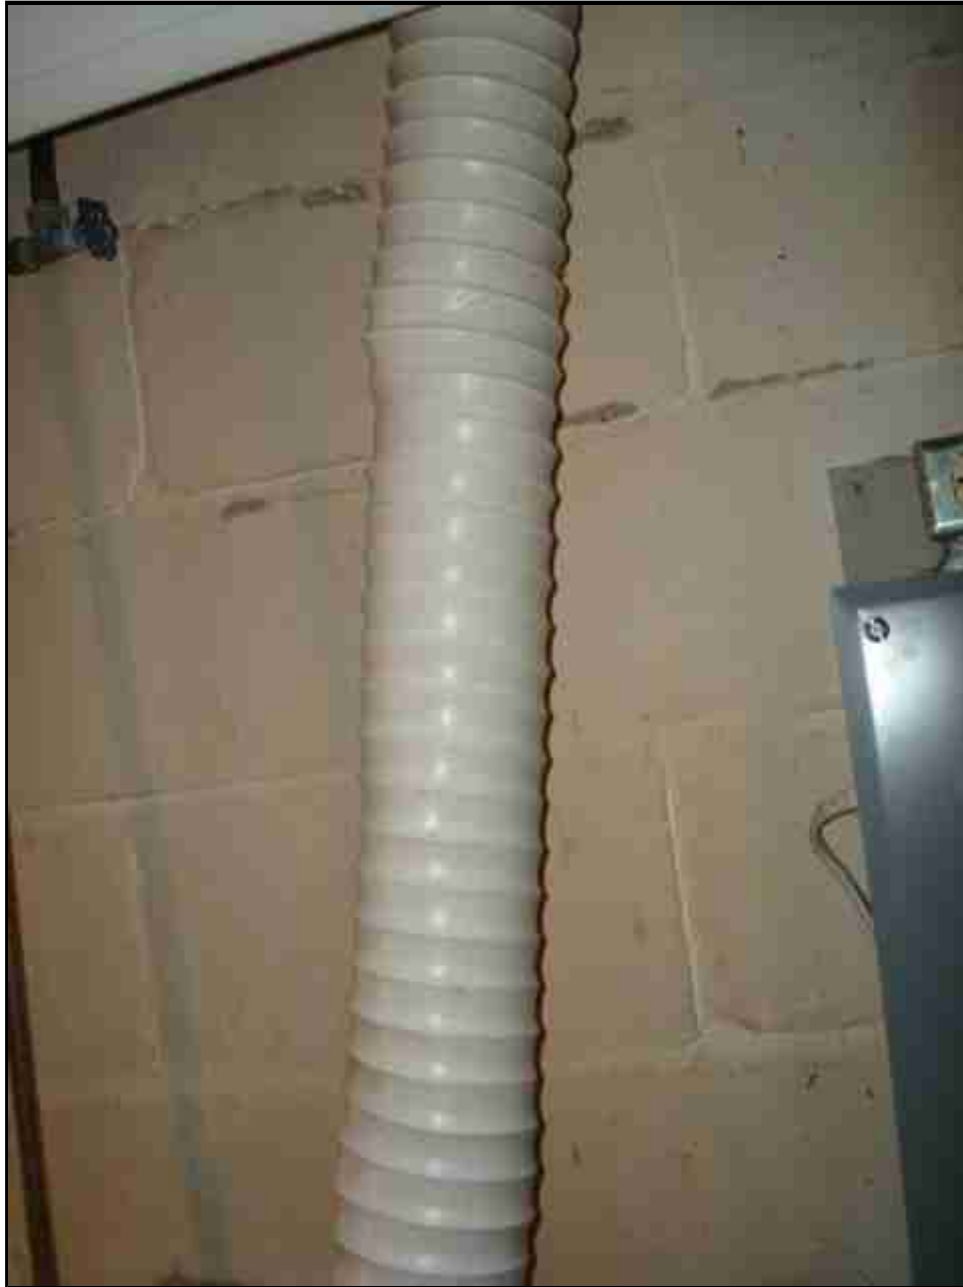
10.10 Picture 1

**IMPACT/CONSEQUENCES:** Fire Hazard

**RECOMMENDED ACTION:** Consult with a qualified contractor for replacement.
